**CALSPAN REMOTE AIR BAG/CHILD FATALITY INVESTIGATION  
CALSPAN CASE NO. 96-24  
VEHICLE: 1997 SATURN SL2  
LOCATION: GEORGIA  
CRASH DATE: , 1996**

**CALSPAN REMOTE AIR BAG/CHILD FATALITY INVESTIGATION**

**CALSPAN CASE NO. 96-24**

**VEHICLE: 1997 SATURN SL2**

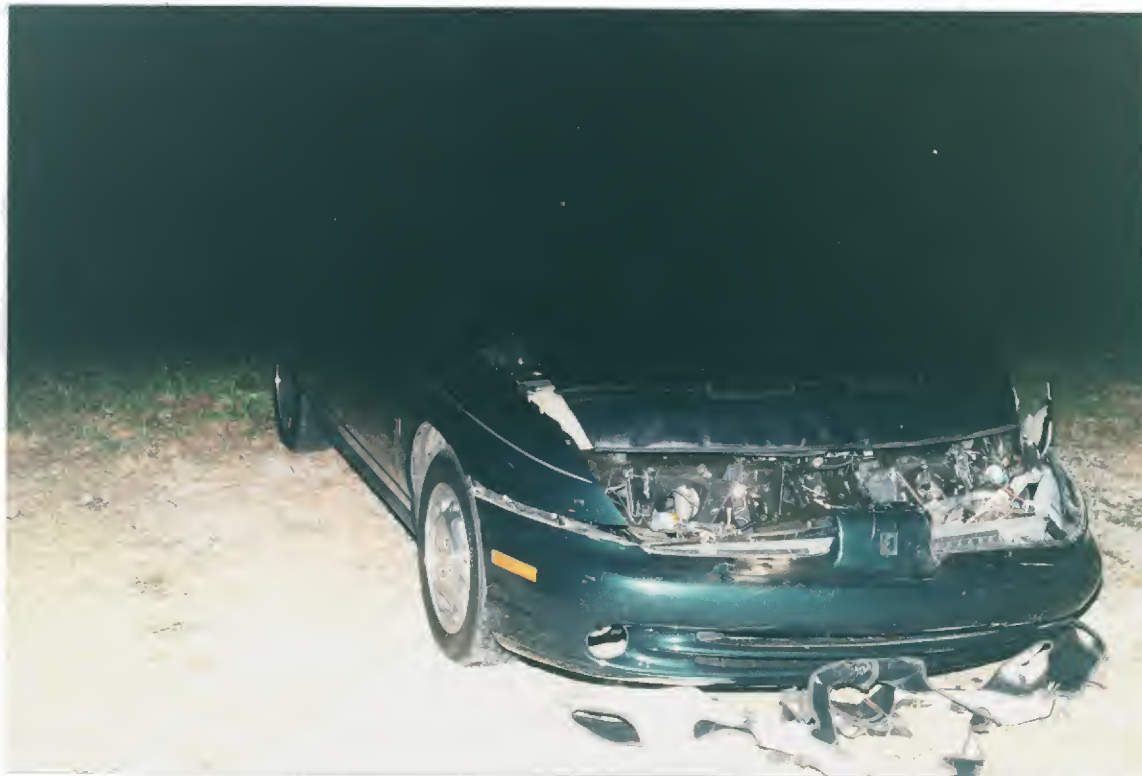
1. Frontal damage to the 1995 Saturn SL2 Sedan.

The full frontal area of the Saturn impacted the rear of the stopped Nissan in a 12 o'clock/6 o'clock configuration. The front bumper of the Saturn initially engaged against the rear bumper of the Nissan which resulted in minimal bumper displacement. The Saturn's bumper subsequently underrode the rear bumper of the Nissan resulting in moderate damage to the grille and headlamp areas of the Saturn. A CDC of 12-FDEW-1 was derived from the attached on-scene police photographs. The Saturn sustained a moderate velocity change that was estimated from the attached police photographs at 16-19 km/h (10-12 mph). As a result of the crash, the Saturn's supplemental driver and passenger side air bag system deployed.

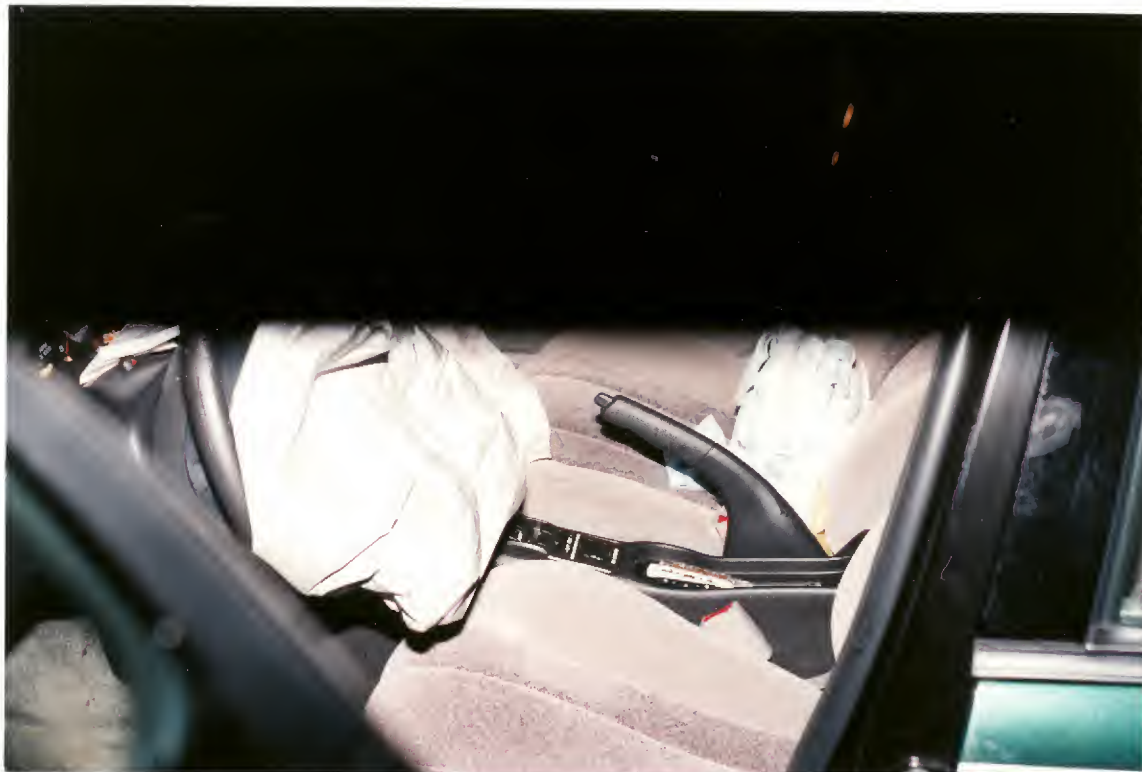
2. Deployed driver's side air bag and front seat track positions.

The driver of the Saturn probably responded to the frontal impact by initiating a forward trajectory and loaded the deployed driver's side air bag. Although he did not sustained direct contact injury from the bag, the right front passenger noted that he complained of neck pain that probably resulted from bag loading and the frontal impact force.

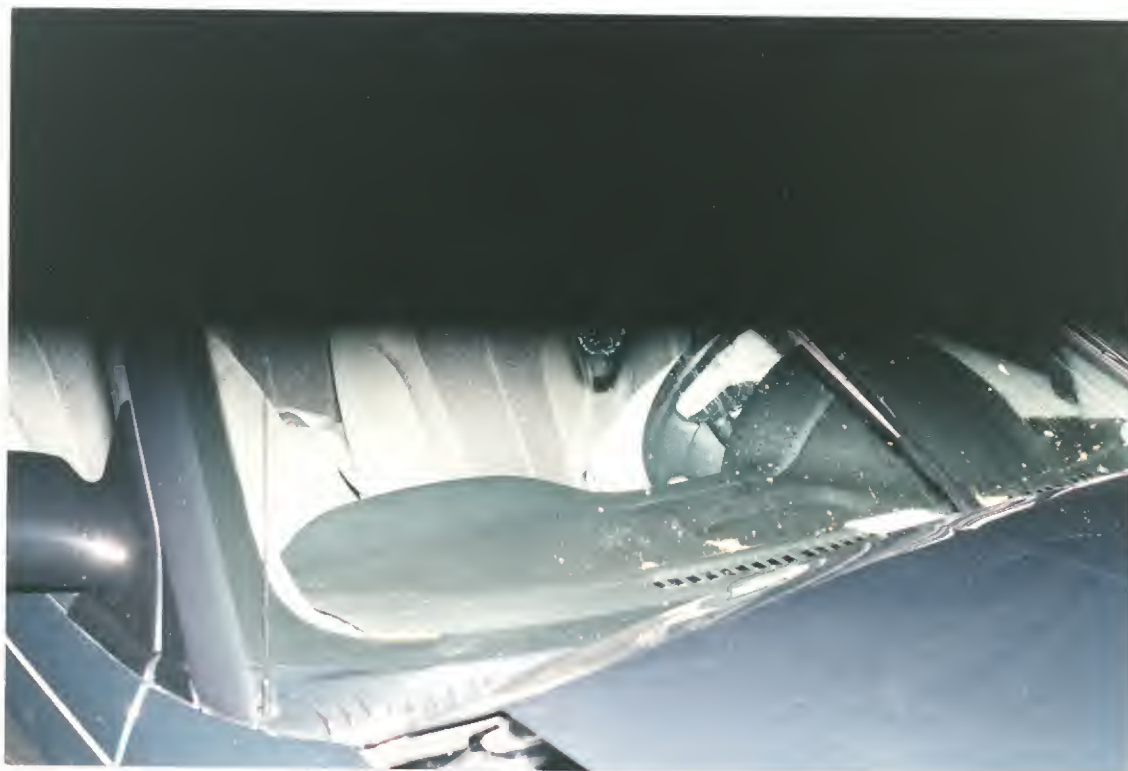
3. Exterior view of the interior and apparent food debris on interior surface of windshield and upper instrument panel.

The mother stated that the lower aspect of the air bag contacted the child's face and chest while the upper aspect of the passenger side air bag contacted her chest which resulted in contusions (AIS-1). The mother further noted the deployment sequence displaced the child from her arms to a position on the right front floor where she came to rest within the vehicle. The air bag probably displaced the child into the chest of the mother as she responded to the frontal impact force. The mother sustained contusions (AIS-1) and soreness of the chest, however, she declined medical treatment. In addition to holding the child on her lap, the mother was probably holding some fast-food items which were scattered about the frontal interior surfaces as evidenced in Photograph No. 3.

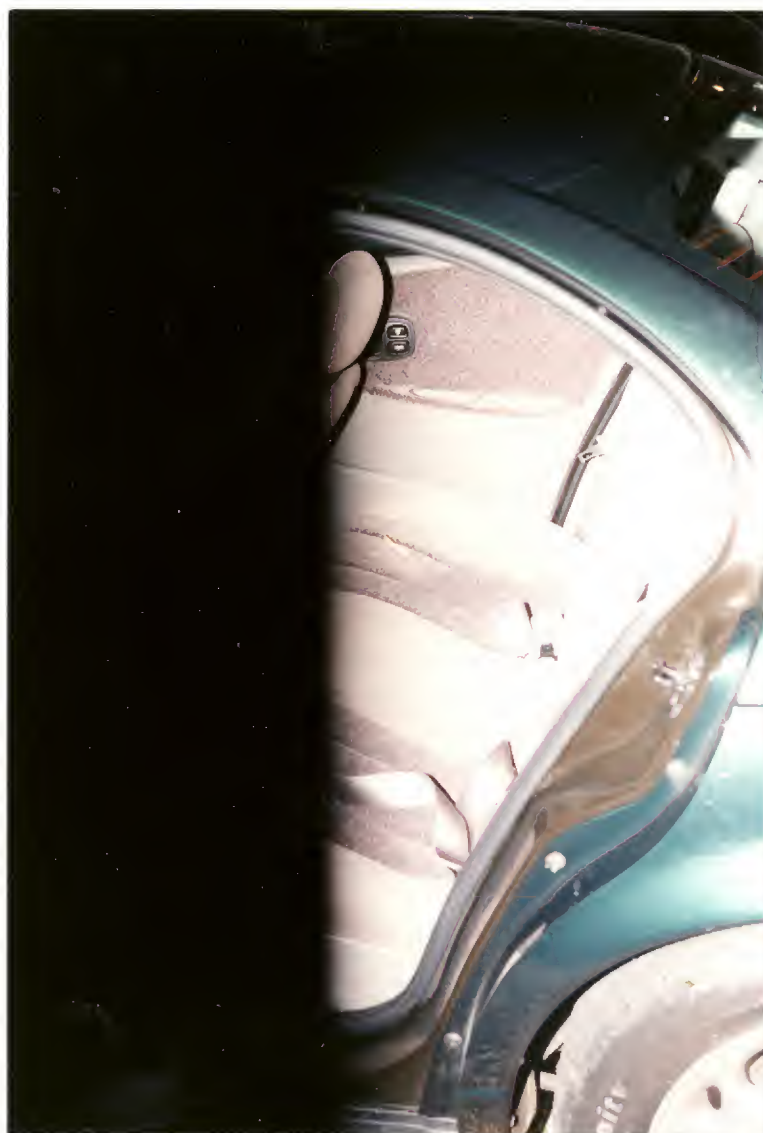
4. Rear seat view of the Saturn.

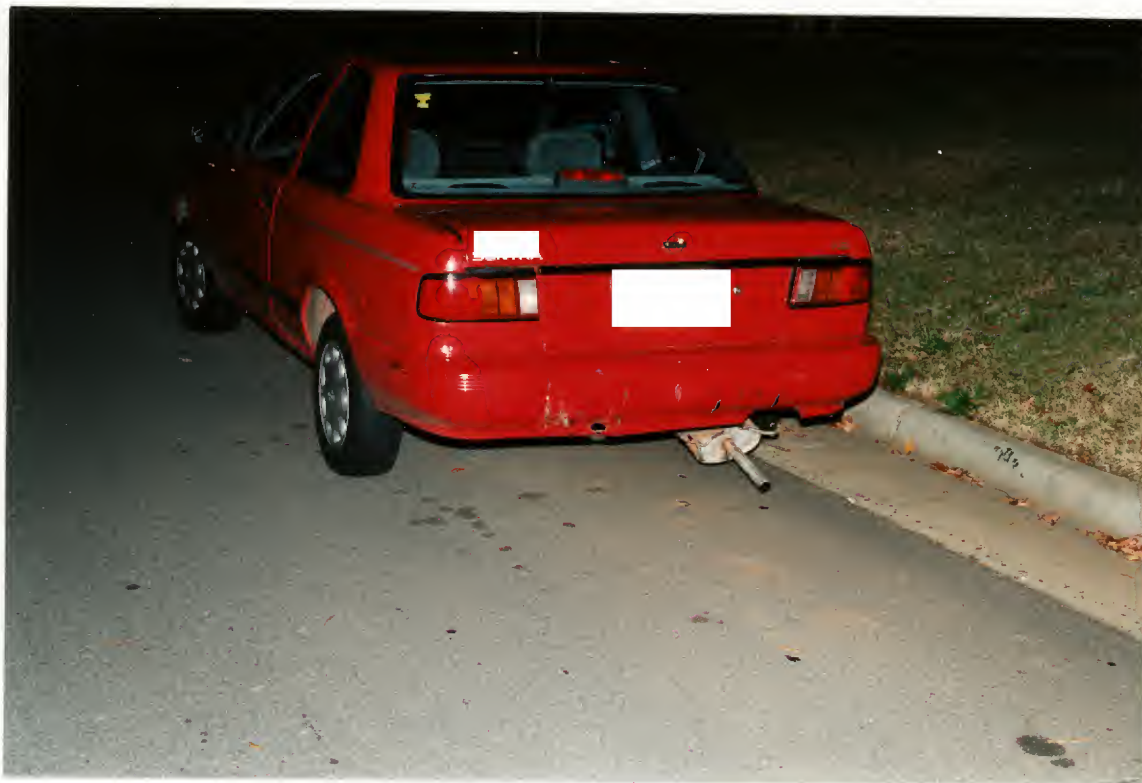
5. Rear view of the struck 1994 Nissan Sentra.

The rear bumper fascia of the Nissan was abraded and holed from the impact sequence with the Saturn. As the Saturn's bumper fascia underrode the Nissan's bumper, the Nissan's rear mounted muffler was contacted and displaced forward which separated the muffler from the rear exhaust hangers (refer to Photograph Nos. 5 and 6). There was no damage above the level of the Nissan's bumper (CDC 06-BDLW-1). The impact displaced the Nissan forward into the rear of a stopped 1990 Buick Century.

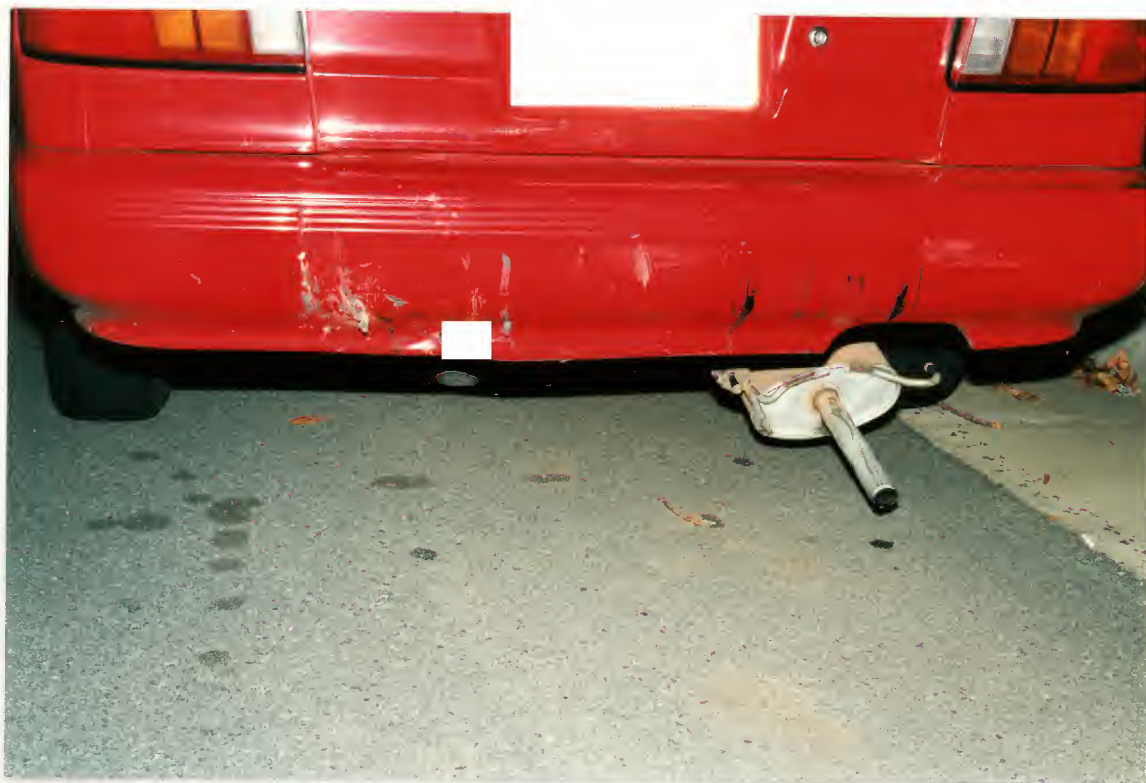
6. Close-up view of the rear bumper fascia and disengaged muffler assembly.
